EFFECT OF MATRIX RESIN ON THE IMPACT FRACTURE CHARACTERISTICS
OF GRAPHITE-EPOXY LAMINATES

NASA Contractor Report 165784

P. E. Hertzberg, B. W. Smith, and A. G. Miller

Boeing Commercial Airplane Company
Seattle, Washington

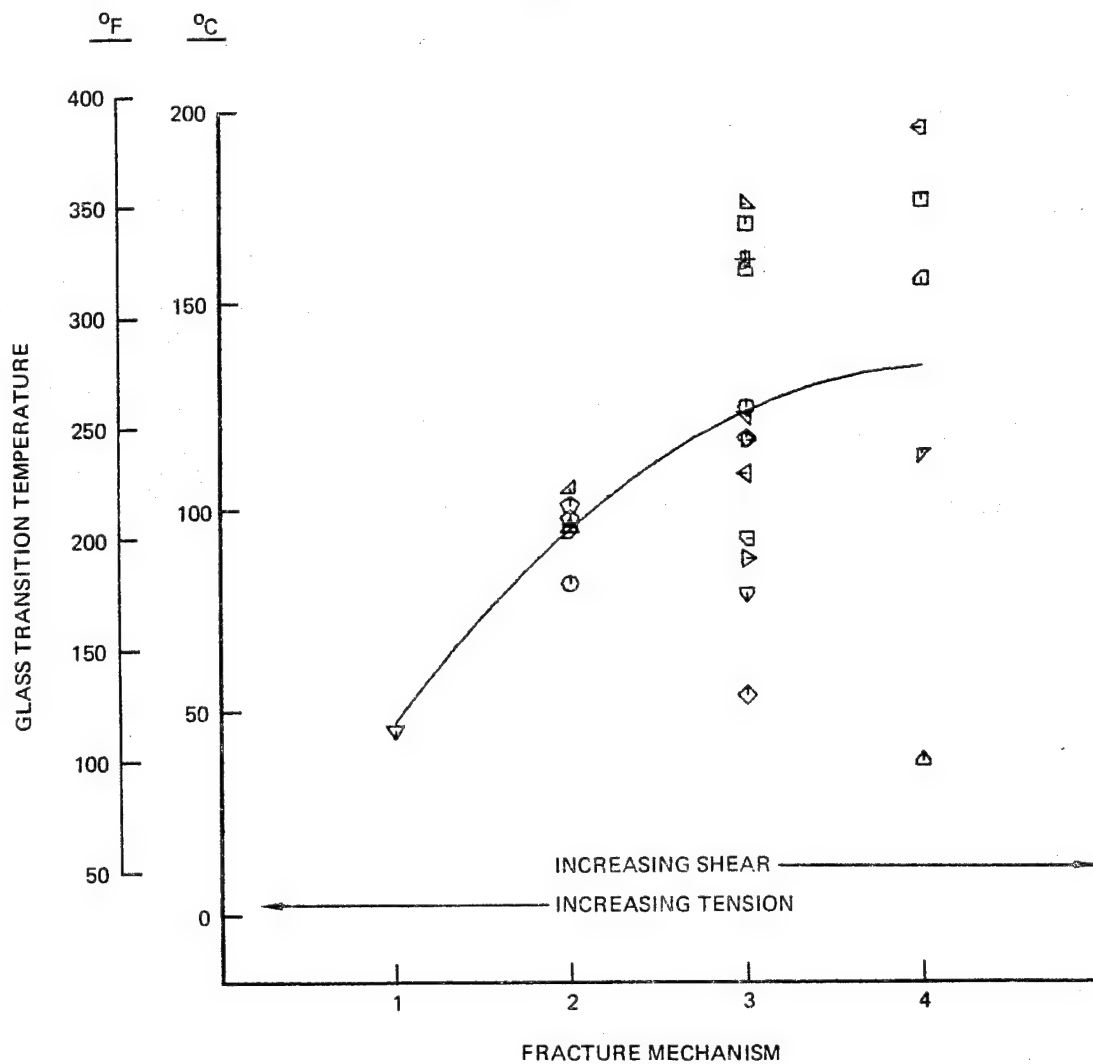
Figure 2. Fracture Mechanism Versus Glass Transition Temperature, As-Received Specimens

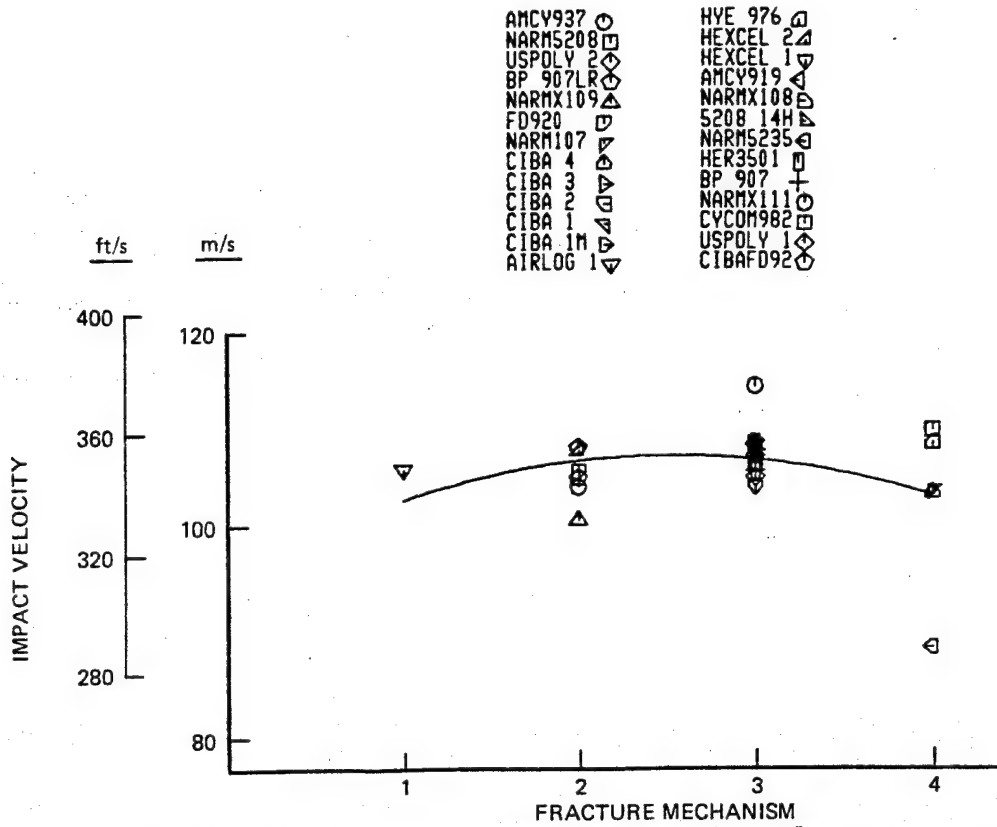
Figure 3. Fracture Mechanism Versus Impact Velocity, As-Received Specimens

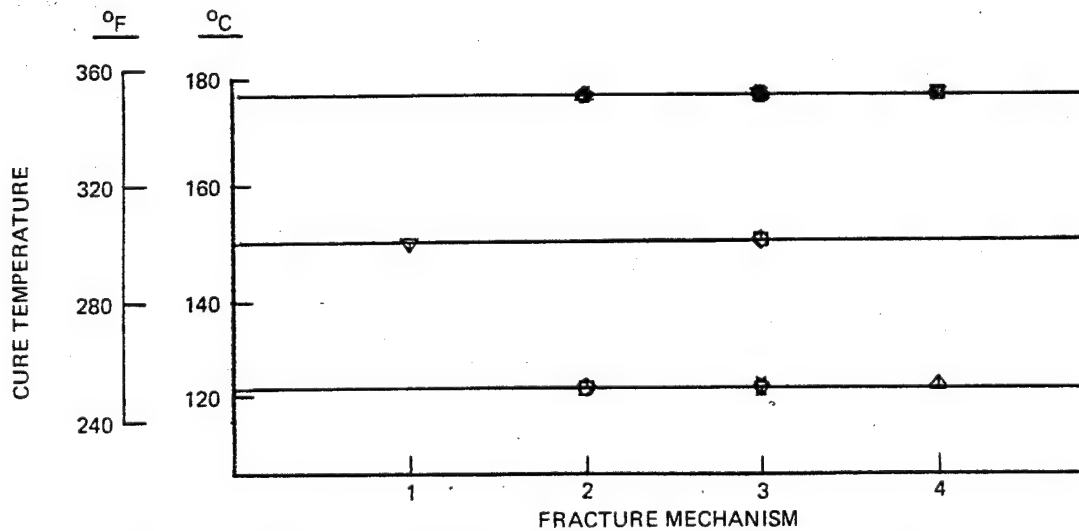
Figure 4. Fracture Mechanism Versus Cure Temperature, As-Received Specimens

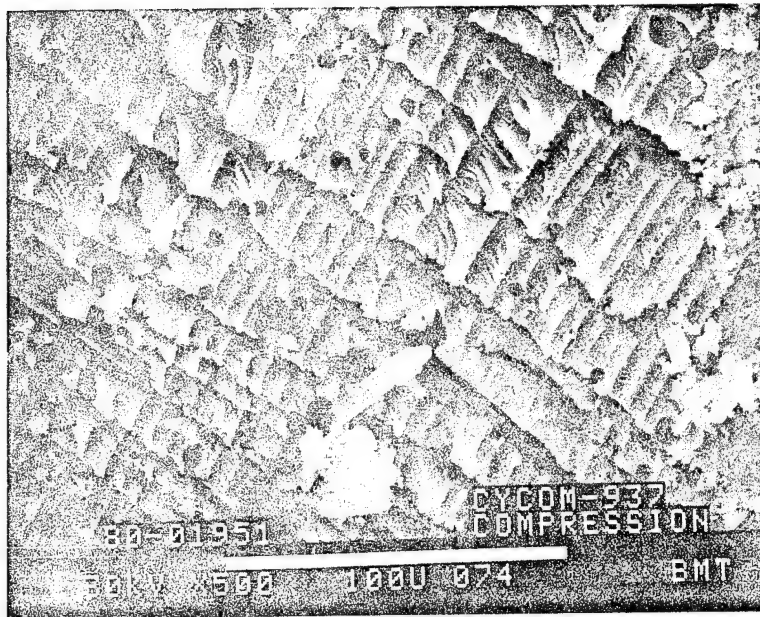
Figure 25. Static Notched Shear Failure, Propagation Zone, Cycom 937 (500X)

Note: Voids are not crack origins.

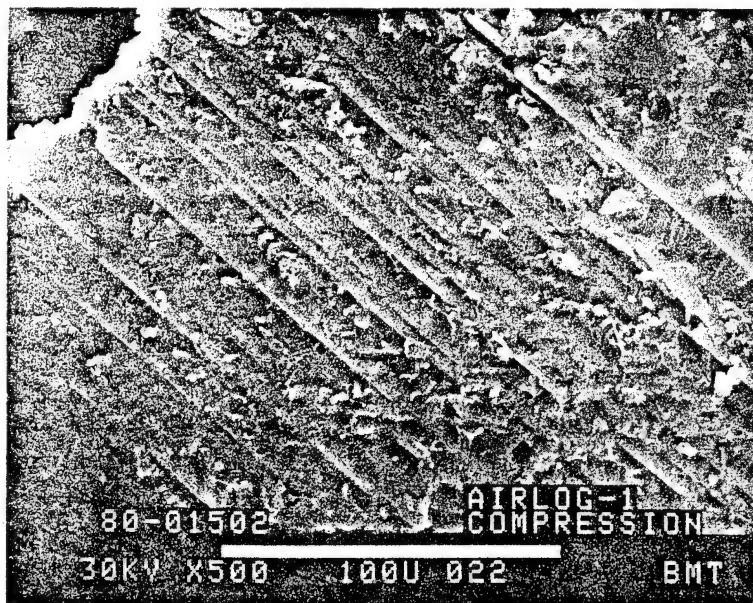
Note plastic flow between fibers.

Figure 36. Compression Shear, Air Logistics 1 (500X)

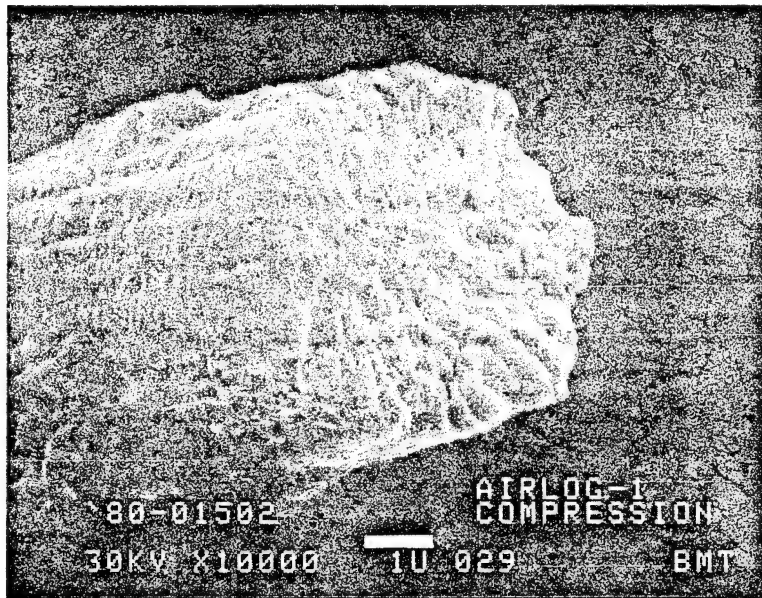
Figure 40. Fiber-Matrix Bond, Compression Side, Air Logistics 1 (10,000X)

Note cohesive failure.

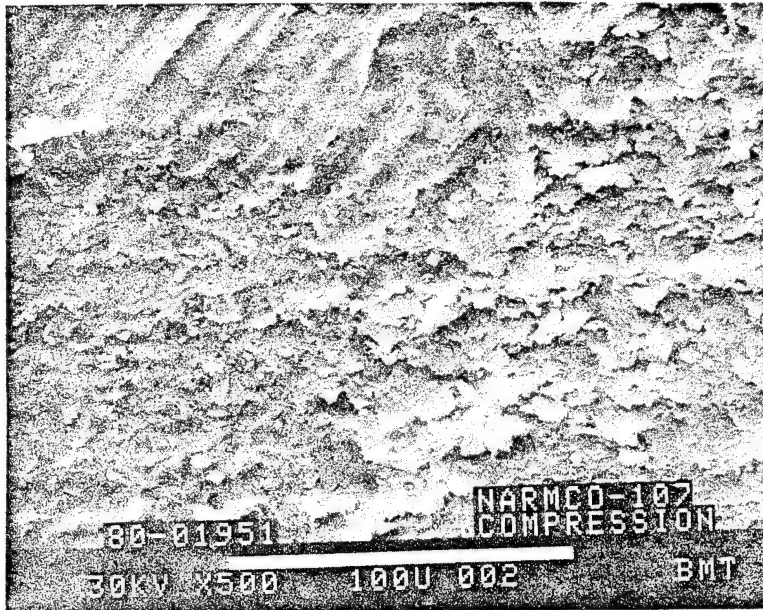
Figure 49. Compression Shear, Narmco 107 (500X)

Note: Same area as figure 47.

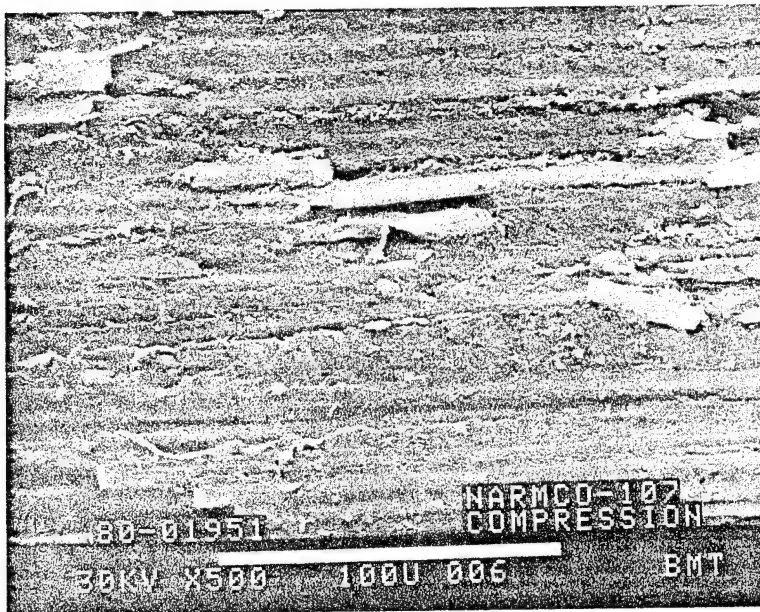
Figure 50. Transverse Fracture of 90-deg Ply, Narmco 107 (500X)

Note: Same area as figure 48.

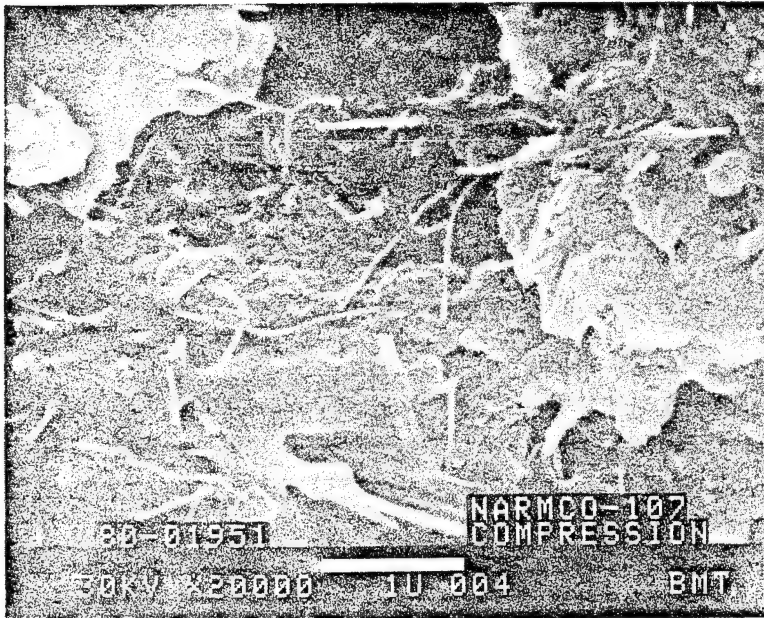
Note that hairs are part of larger resin blocks.

Figure 53. Compression Shear Hairs, Narmco 107 (20,000X)

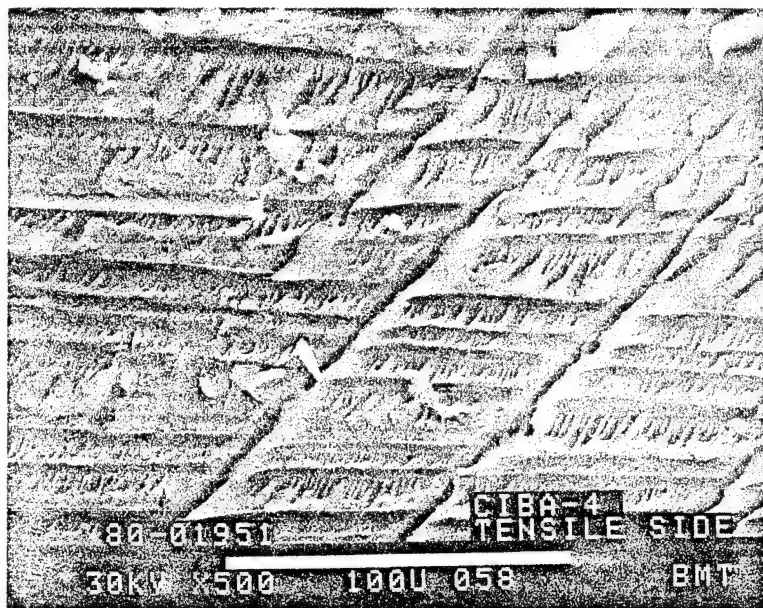
Figure 55. Apparent Brittle Fracture, Delamination Face, Ciba 4 (500X)

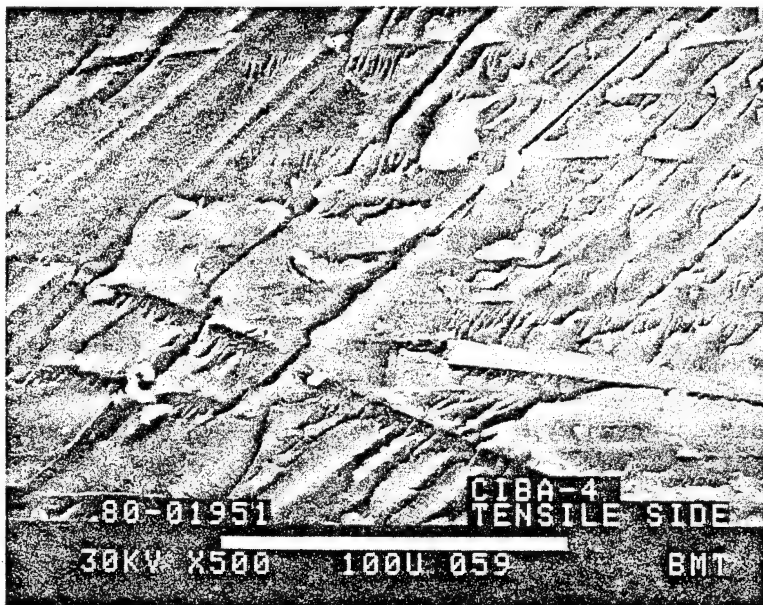
Figure 56. Apparent Brittle Fracture, Ciba 4 (500X)

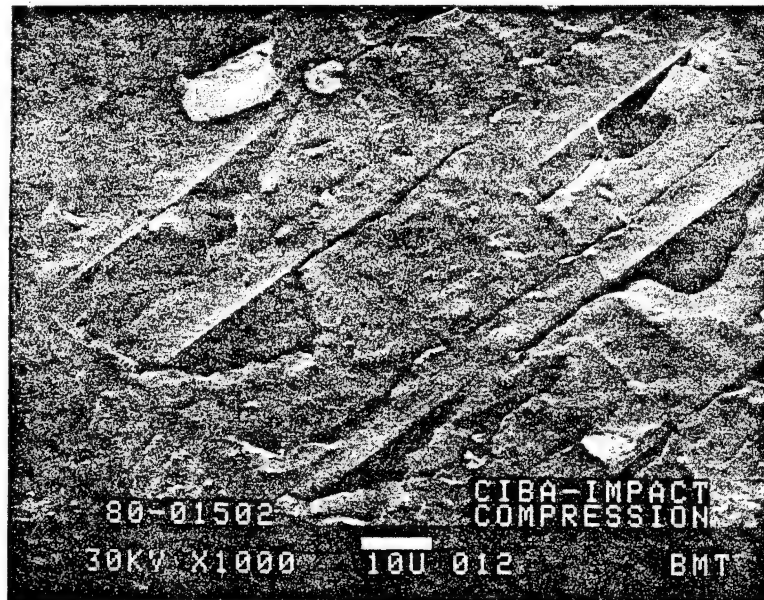
Figure 76. Influence of Voids on Fracture, Ciba 1M (1000X)

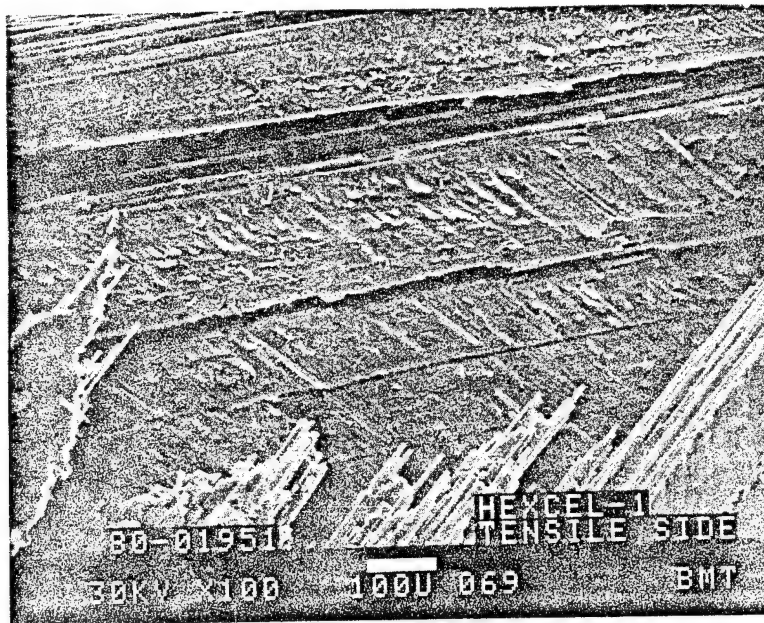
Figure 77. Delamination Plane with Transverse Cracks, Hexcel 1 (100X)

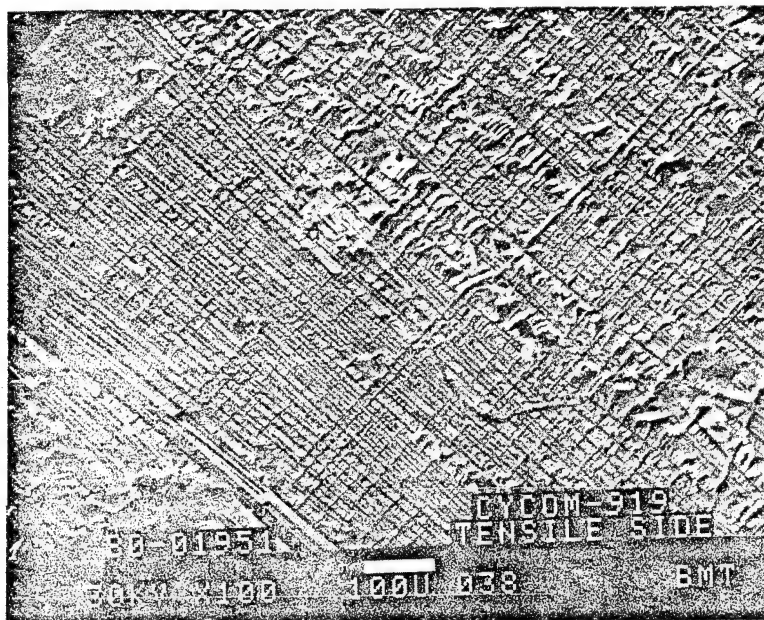
Figure 85. Apparent Brittle Fracture, Cycom 919 (100X)

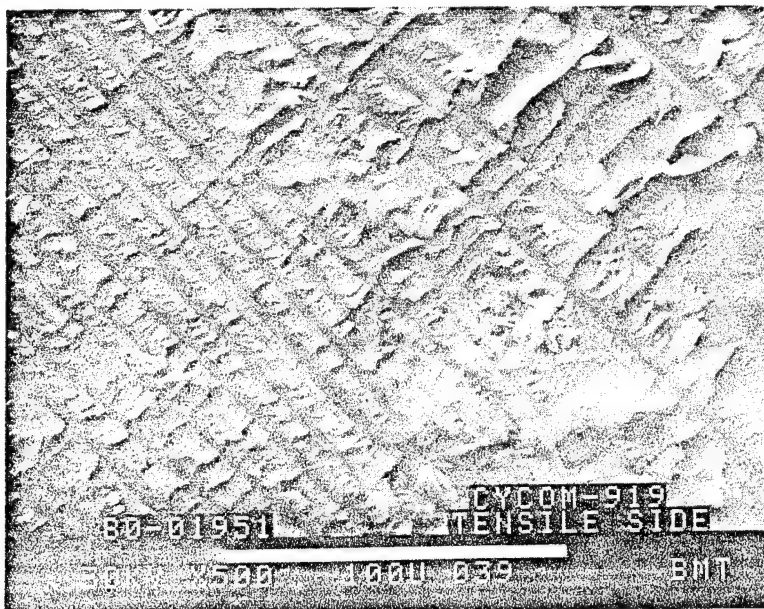
Figure 86. Apparent Brittle Fracture, Cycom 919 (500X)

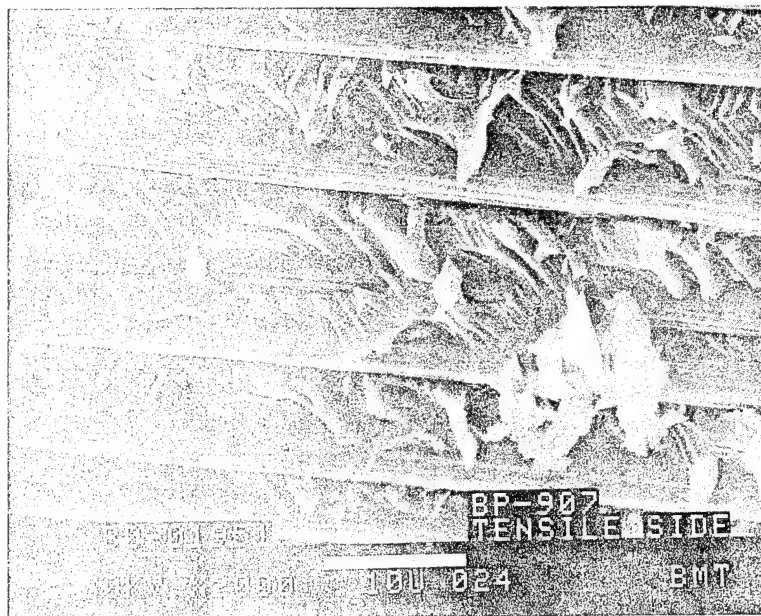
Figure 97. Ductile Resin Failure, BP-907 (2000X)

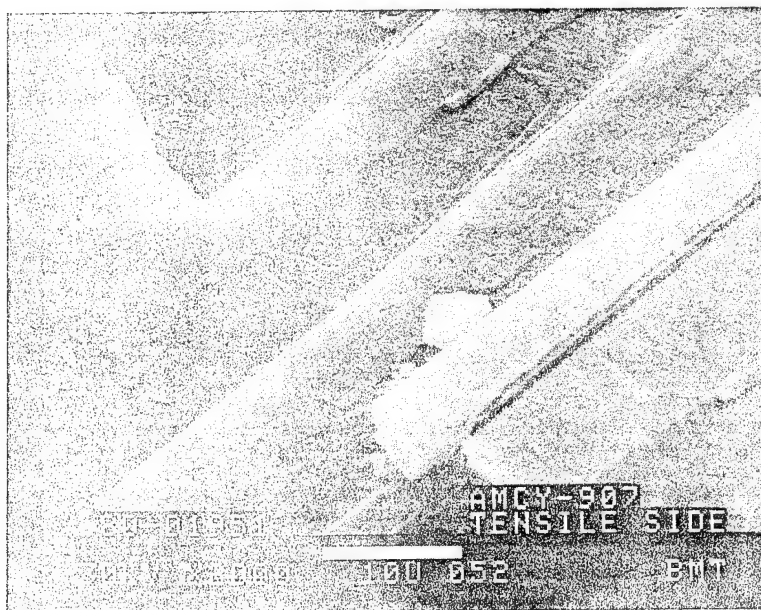
Figure 98. Brittle Cleavage Failure, BP-907-LR (2000X)

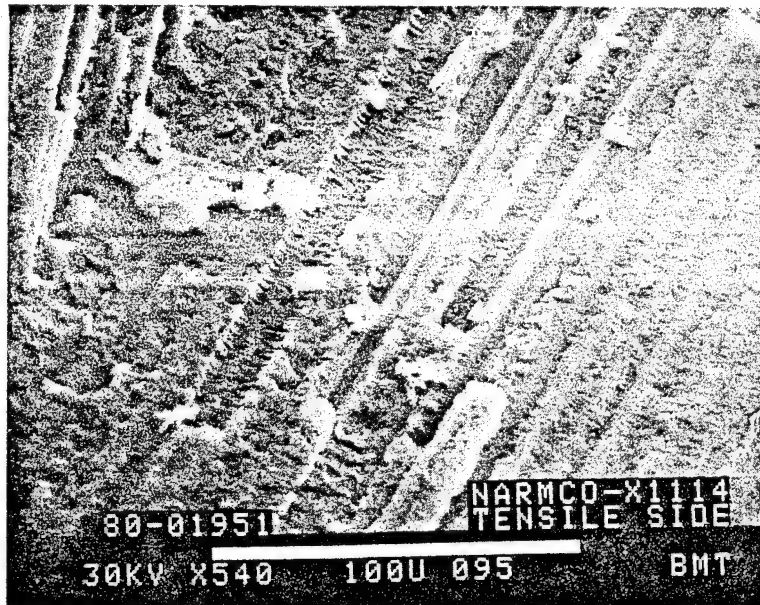
Note stretched and collapsed resin.

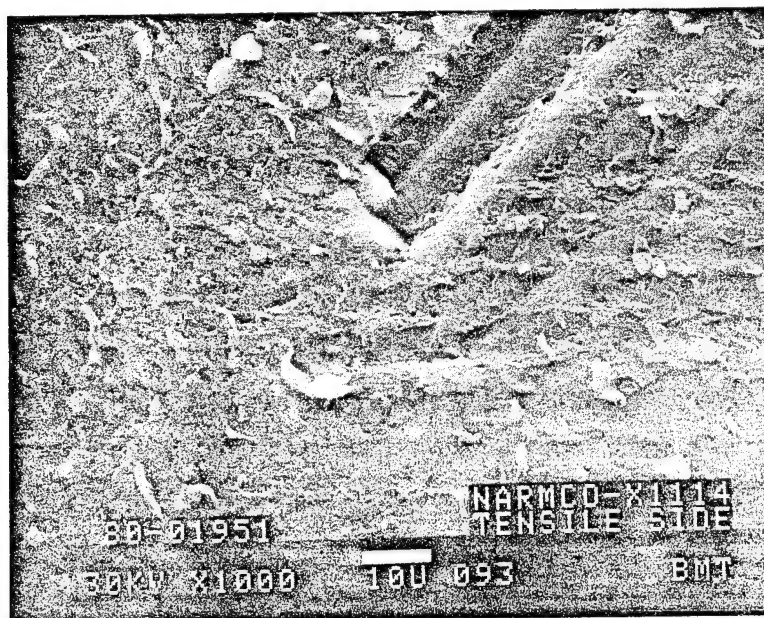
Note lack of propagation of fiber failure.

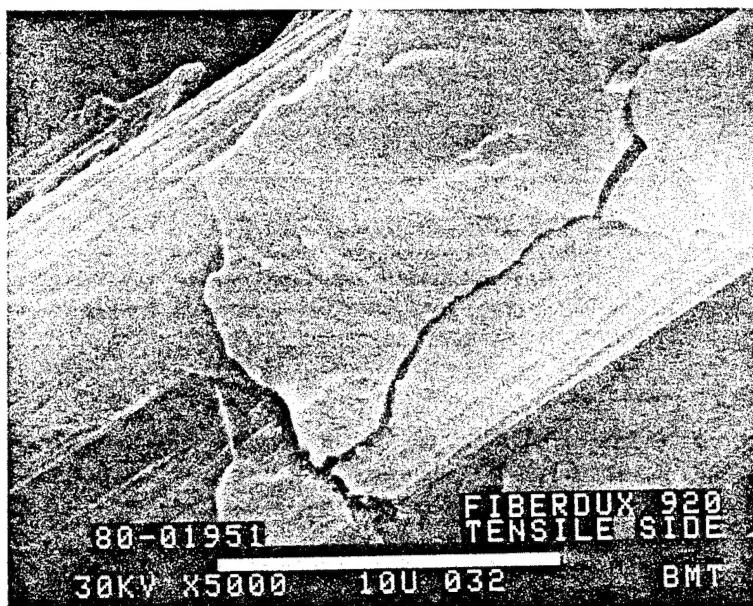
Figure 124. Crack Propagation After Fiber Failure, Fibredux 920 (5000X)
